Re-engineering and function testing at Handtmann Zittau

Handtmann Zittau – Re-engineering

Handtmann Zittau – Function testing

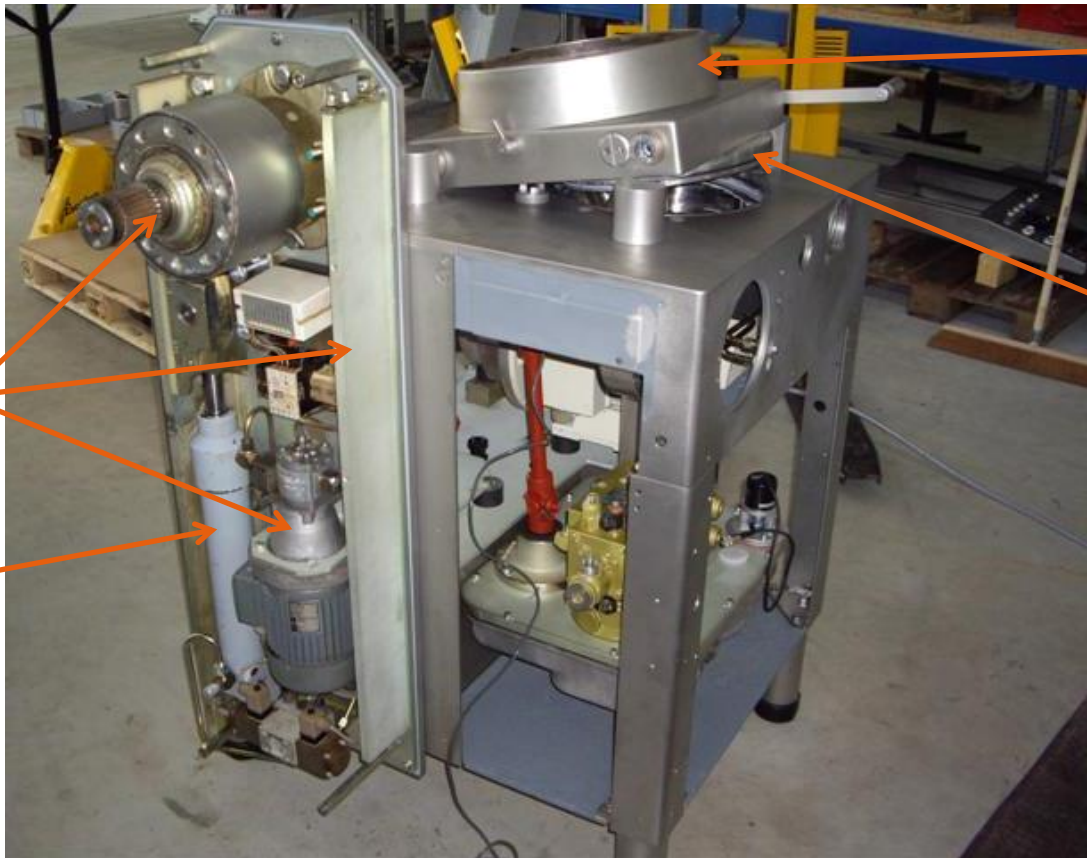
Assembly of a VF 200

Cleaned

Cylinder:
- Inspected
- Cleaned

Swivel housing
- Cleaned
- Shot-blasted

New side plate

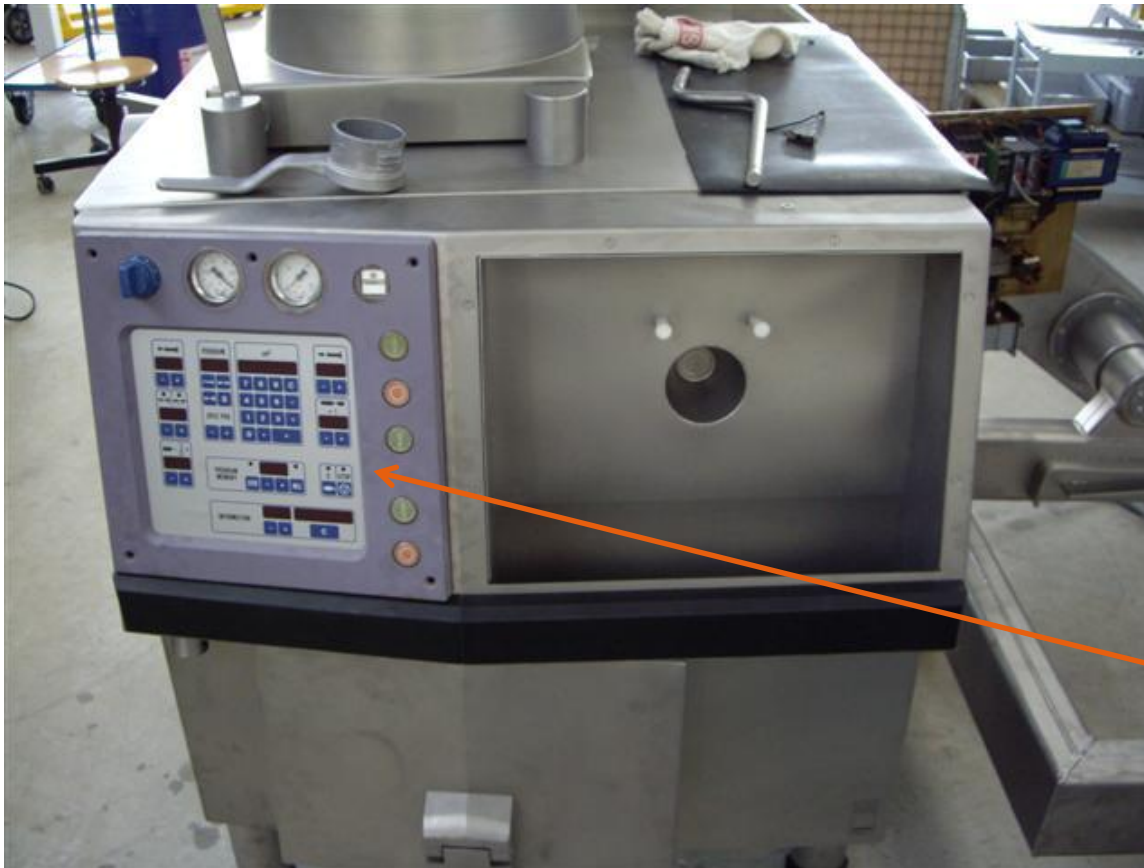
Assembly of a VF 200

- Control checked;
replaced if faulty
- New switches
- New hour counter

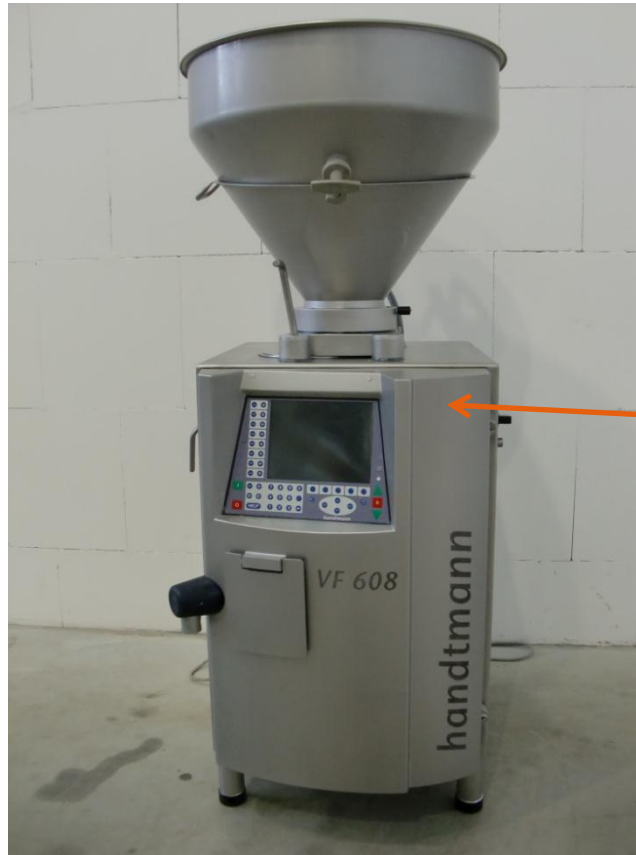
Function testing VF 608

Machine status of
Vacuum Filler checked

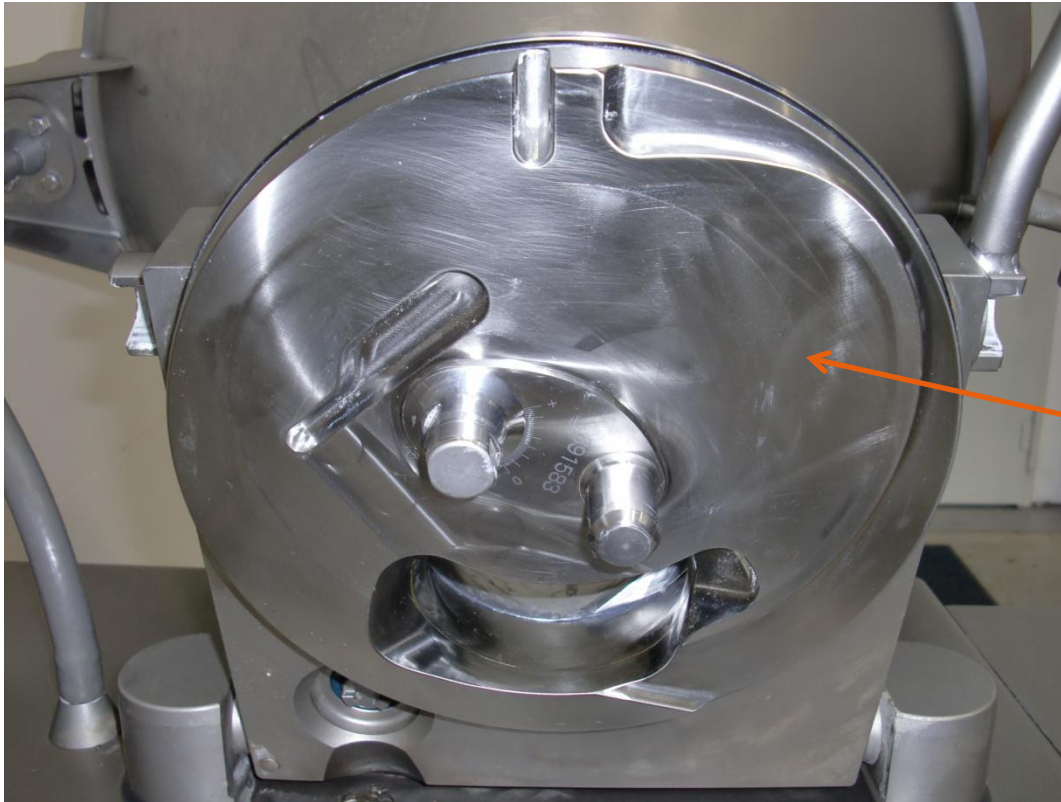
Function testing VF 608

Check of side-plate;
Replaced if cracked or
high wear

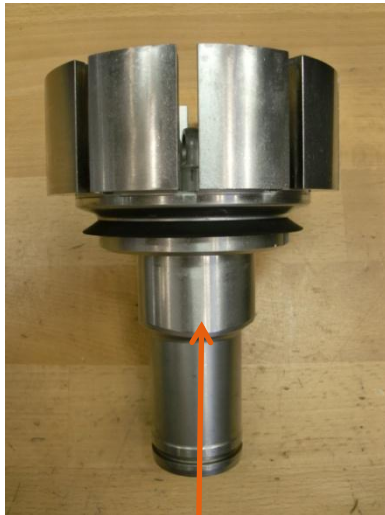
Rotor within tolerance
→ Remain in machine

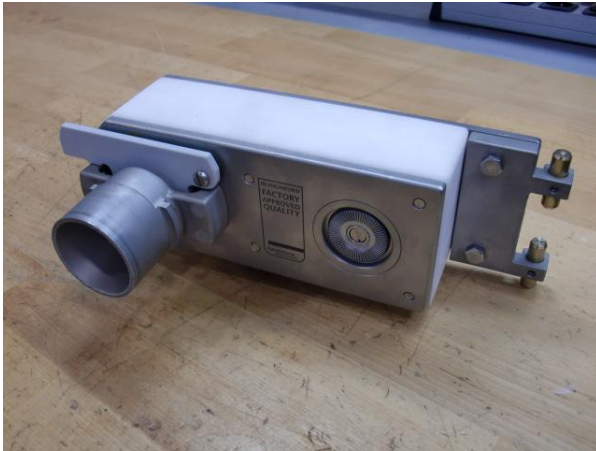
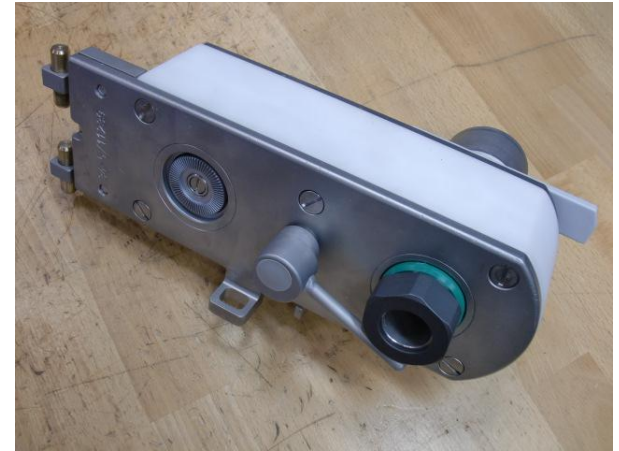
100 % re-engineering of
linking gearbox 34-5

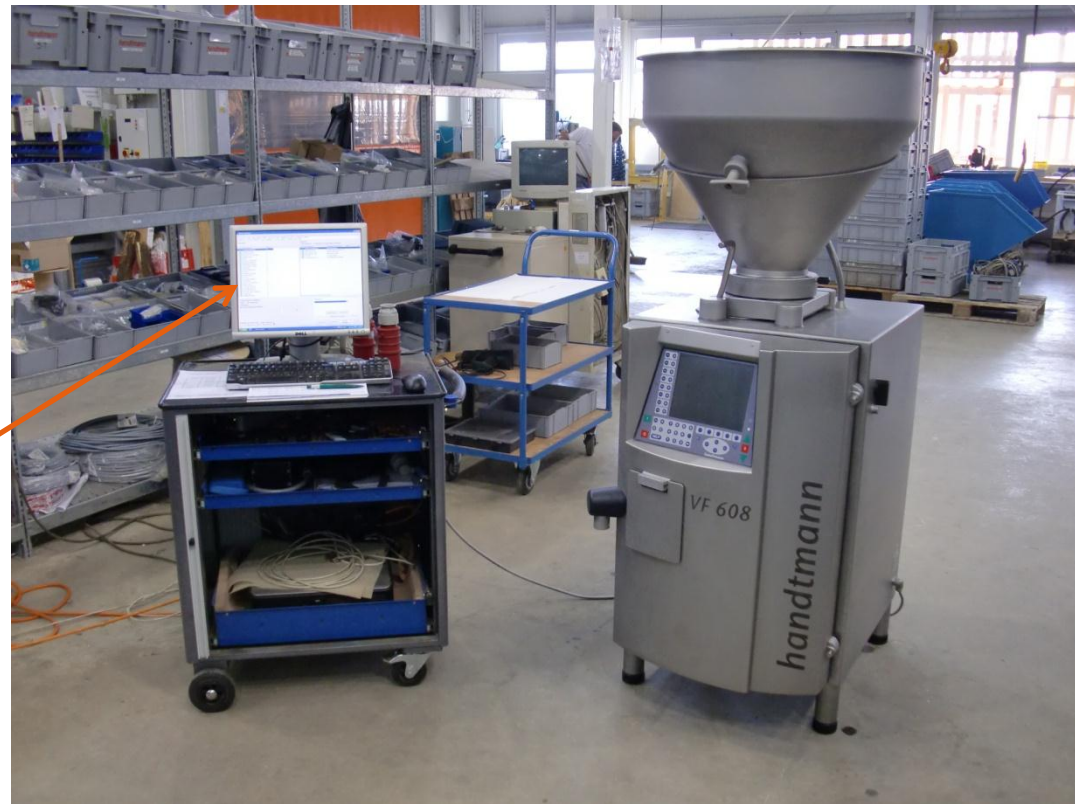
Function testing VF 608

Final inspection of machines with Handtmann Q-Check, like new machines

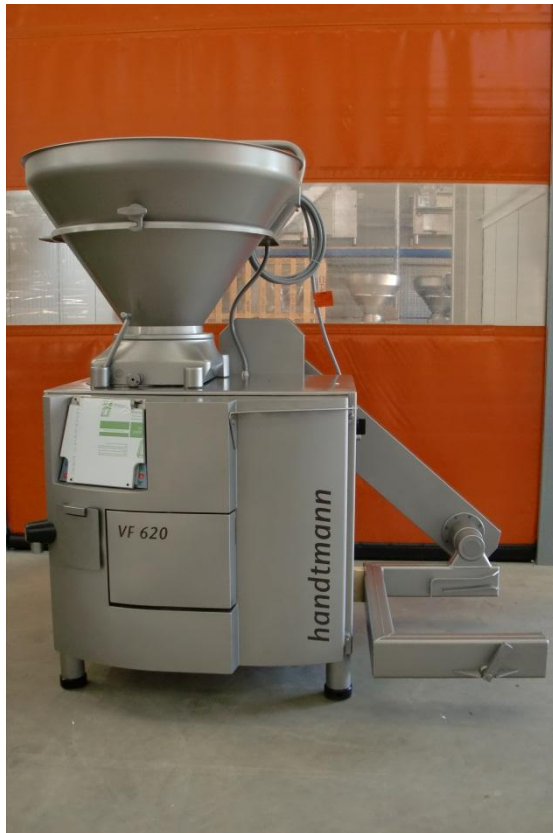
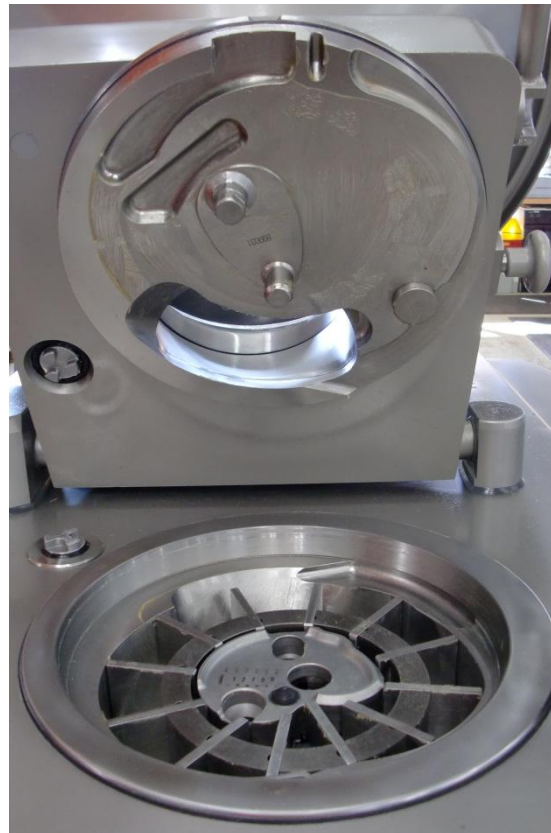
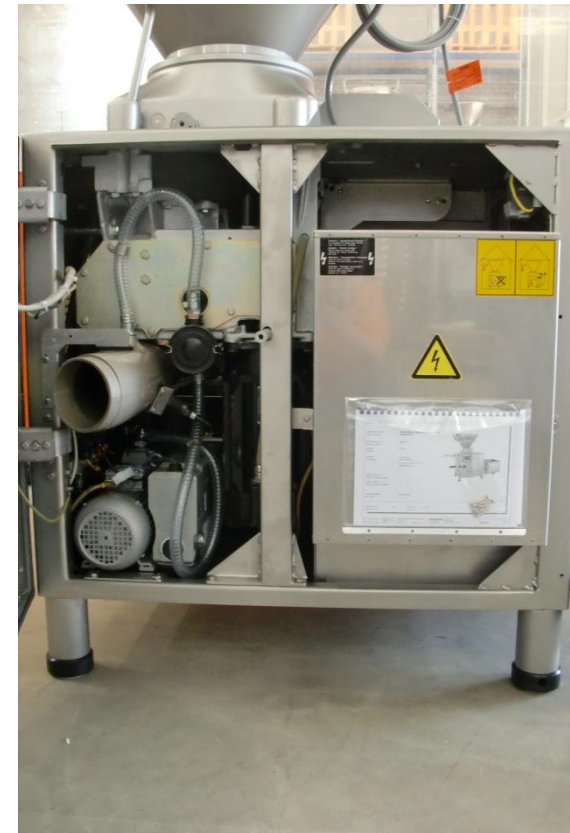
Pictures of a refurbished VF 620, year 2001
